**JOHNSON CONTROLS, INC.
FOWLERVILLE, MI
EPA ID NO. MID099124299**

**FIELD OVERSIGHT REPORT
FOR PHASE III RFI FIELD ACTIVITIES**

FIELD OVERSIGHT REPORT
FOR PHASE III RFI FIELD ACTIVITIES

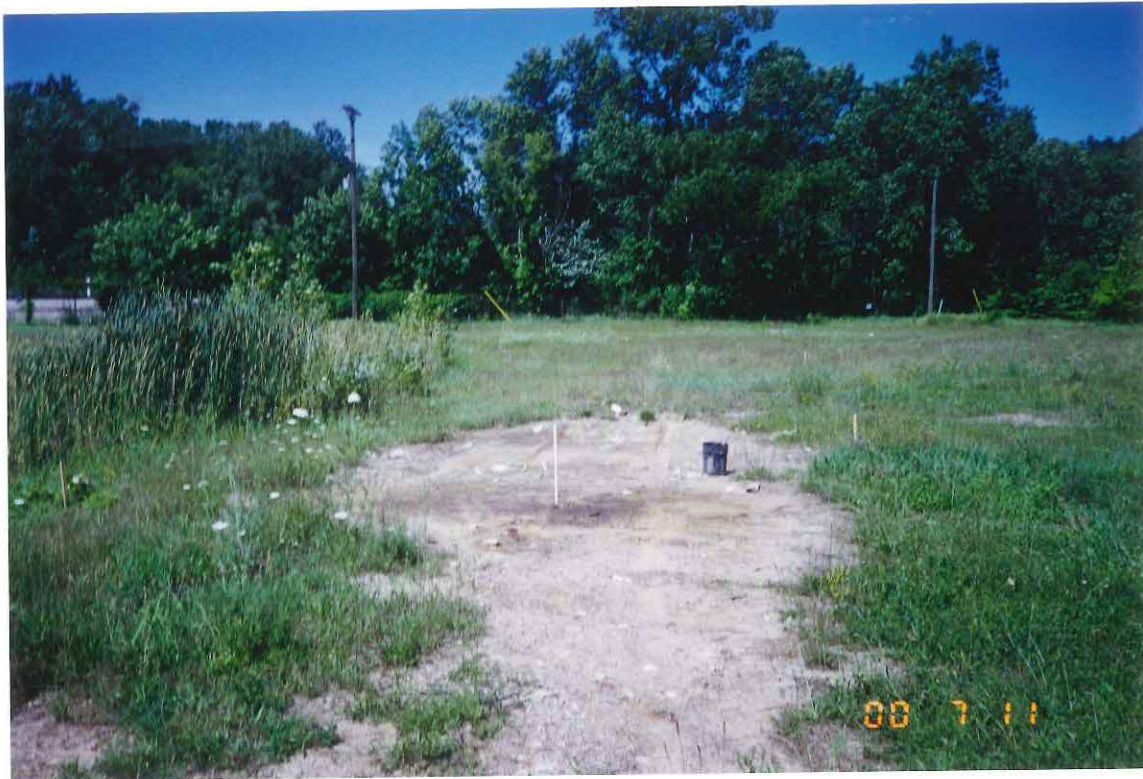
Photograph No.: R1-P2

Description: View of TCE-20 Geoprobe soil boring. This boring exhibited the highest field PID of the day (186 ppm).

During the oversight period, two sampling locations had "hits" on the photoionization detector (PID). These were located at the TCE-15 and TCE-20 locations (see Appendix A for locations). At TCE-15, a PID reading of 57 parts per million (ppm) was registered at approximately seven feet below ground surface (bgs). At TCE-20, 151 ppm was registered at four feet BGS and 186 PPM was registered at eight feet bgs. At TCE-24, a black sandy layer was observed from seven to nine feet bgs. However, this material did not register on the PID meter. Mr. Connair speculated that the material may be degraded kerosene. According to URS, similar material was encountered during soil borings in the SWMU K area. TechLaw was not present for the SWMU K borings.

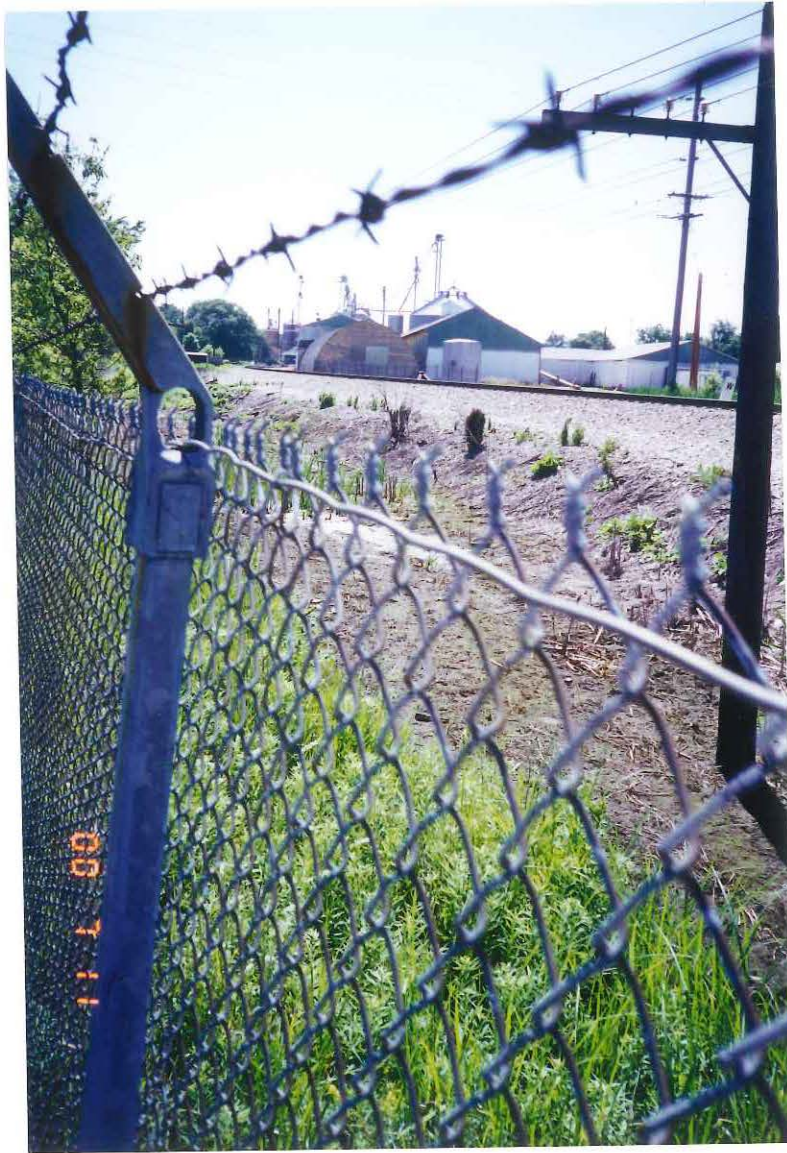
Photograph No.: R1-P4
Date: 07/11/00

Description: View of south drainage ditch located between southern fence line and railroad tracks.

Mr. Connair described conditions at the South Drainage Ditch. This ditch constitutes the southern boundary of the Facility and is located adjacent to railroad tracks. The South Drainage Ditch carries surface water runoff due west to the Red Cedar River. The ditch appeared to contain stressed brown vegetation. Mr. Connair suggested that the stressed nature of the vegetation could be potentially due to pest control activities conducted by the local municipalities. Mr. Connair provided anecdotal information that the local municipalities periodically applied pesticides in areas of standing water.

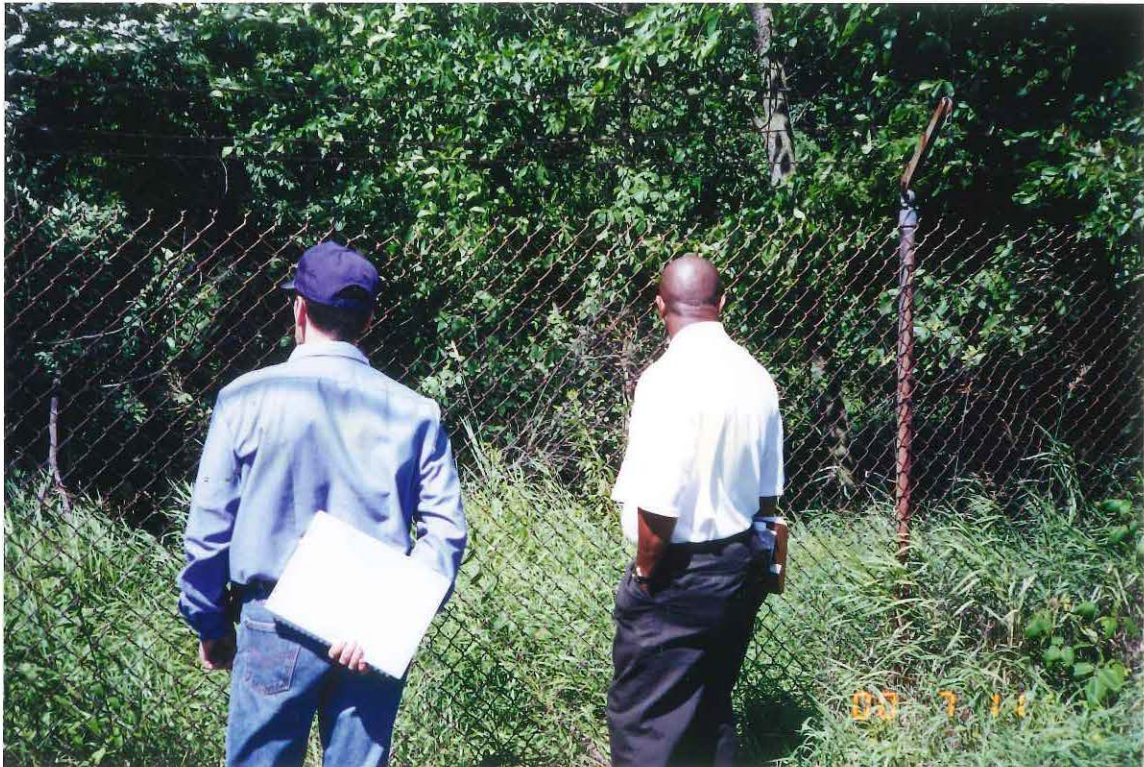
Photograph No.: R1-P6
Date: 07/11/00

Description: View of the Red Cedar River (behind fence) near outfall of South Drainage Ditch.

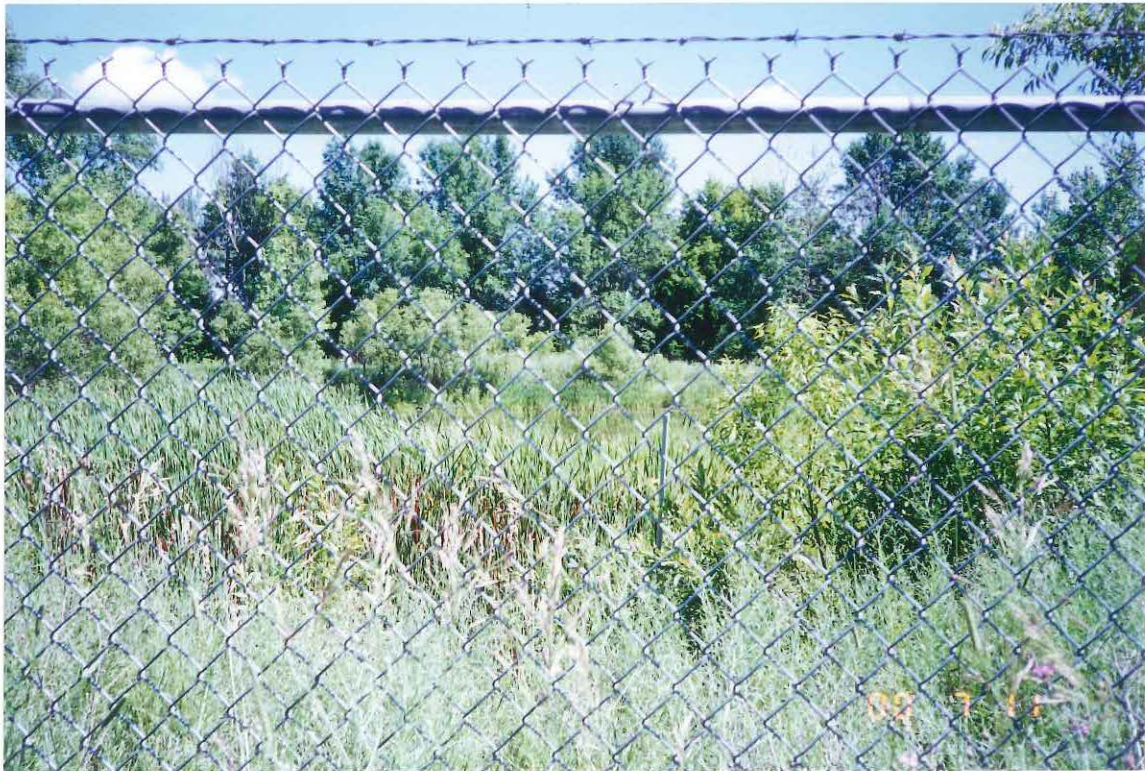
Photograph No.: R1-P7
Date: 07/11/00

Description: View through fence line of Closed RCRA surface impoundments (settling ponds).

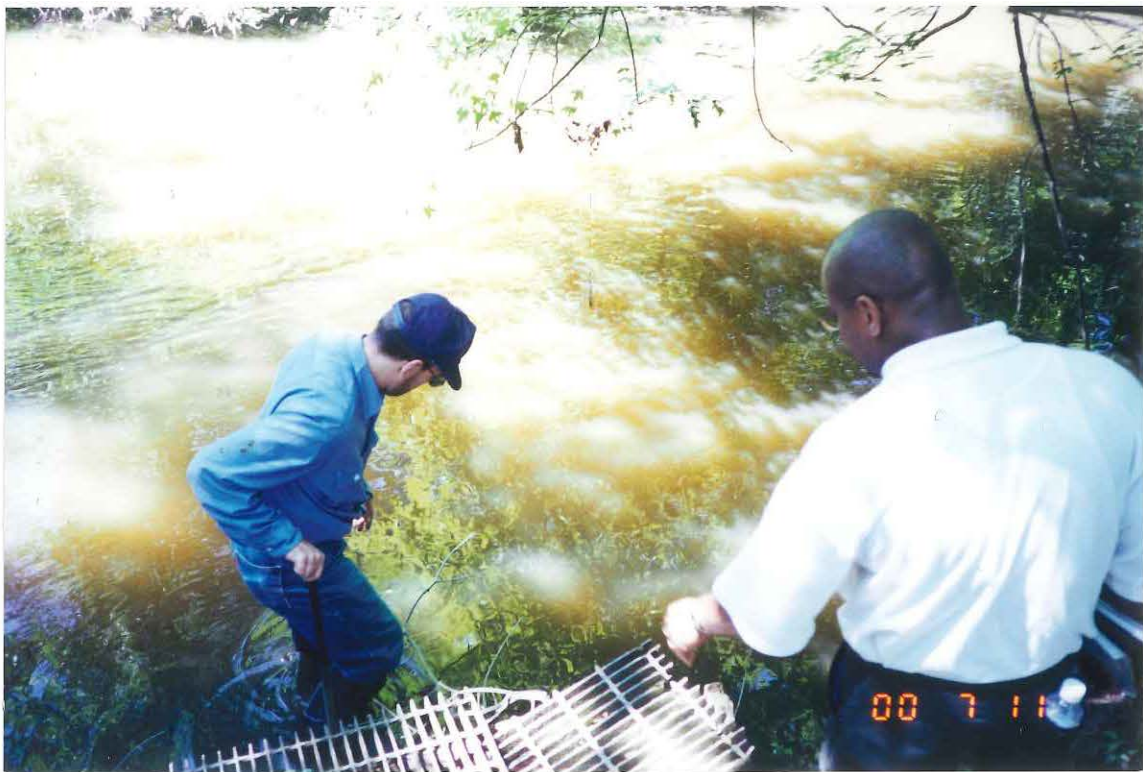
Photograph No.: R1-P8
Date: 07/11/00

Description: View of Mr. Dennis Connair of URS showing elevated and murky conditions of the Red Cedar River.

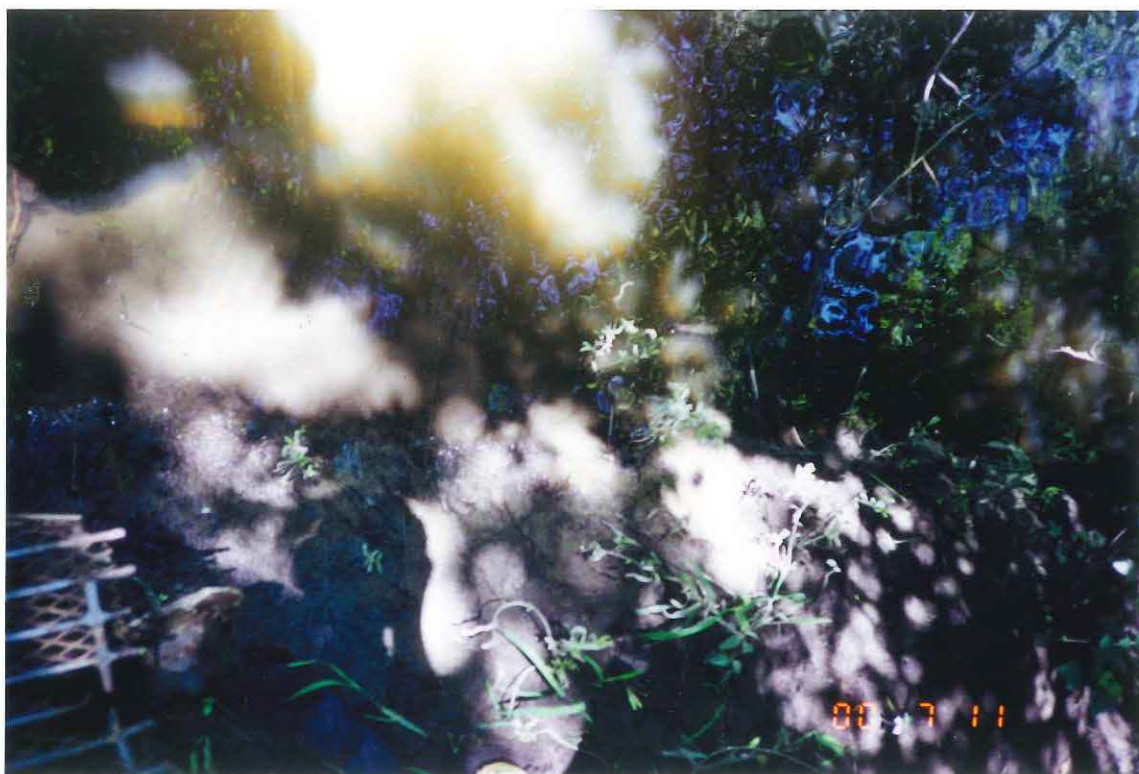
Photograph No.: R1-P10
Date: 07/11/00

Description: View of the northern bank of the Red Cedar River.

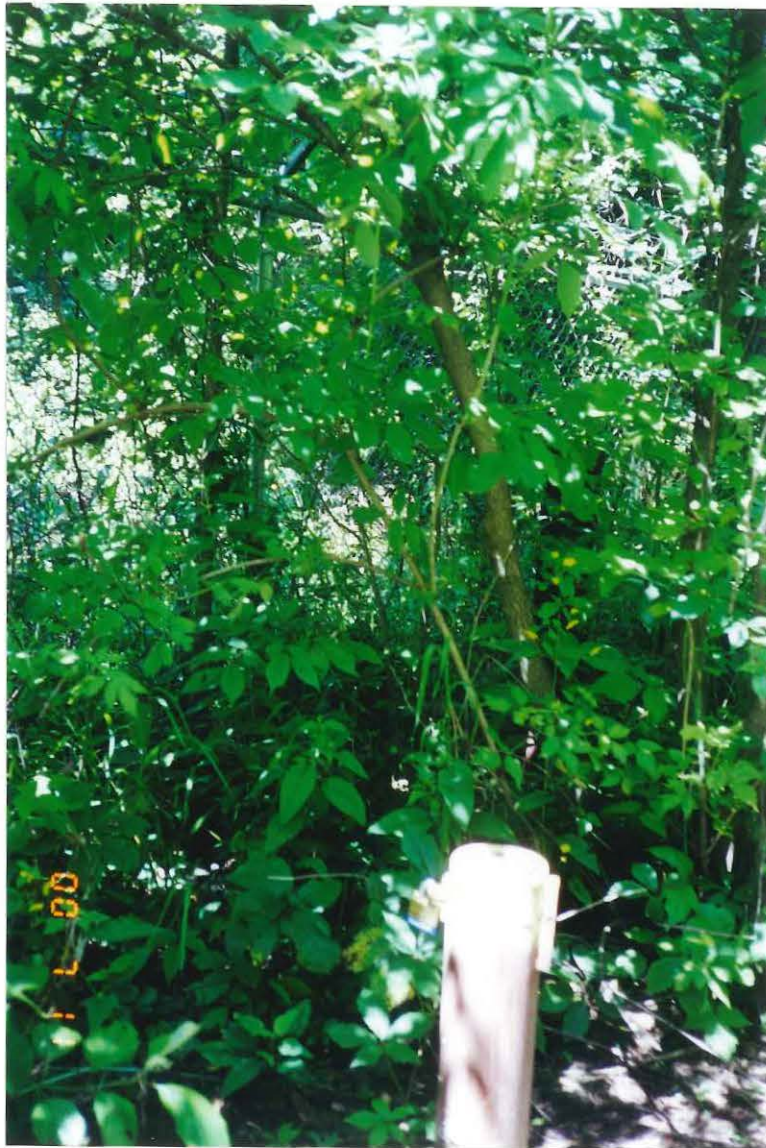
Photograph No.: R1-P13
Date: 07/11/00

Description: View of MW-F2 with Red Cedar River in background.

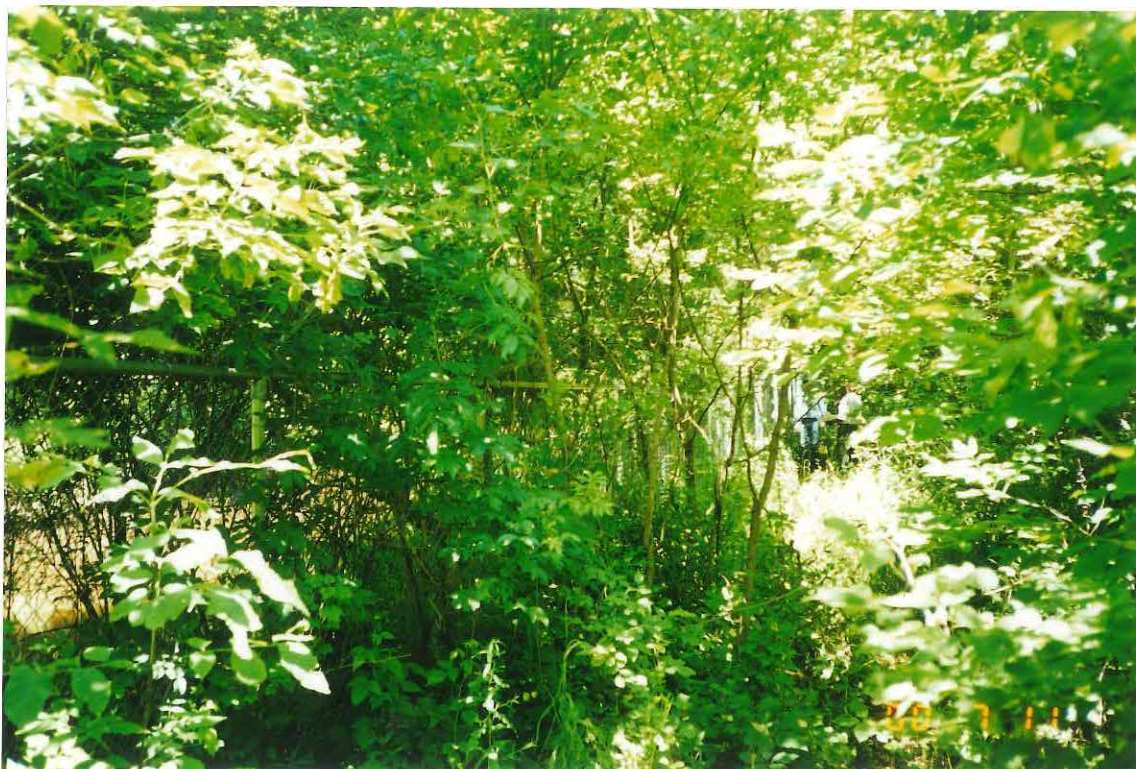
Photograph No.: R1-P14

Description: Additional view of southern fence line of Area F near MW-F1. Red Cedar River to left (south) of fence.

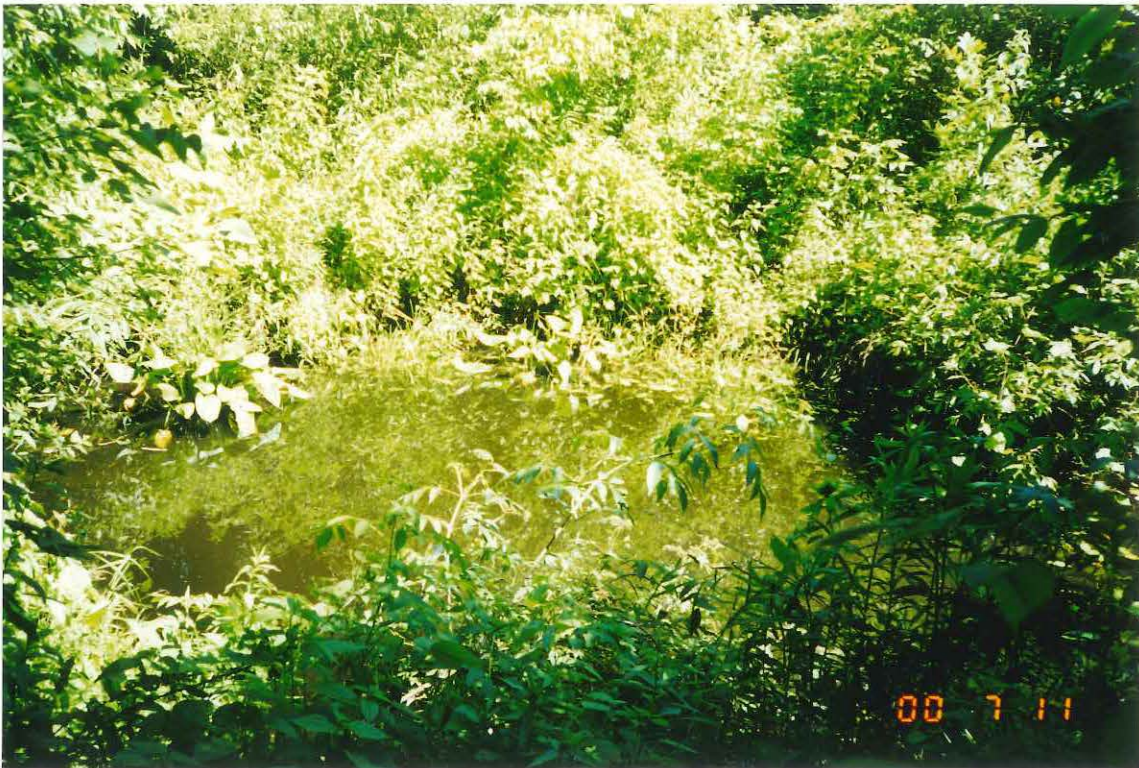
Photograph No.: R1-P15
Date: 07/11/00

Description: View of standing water in Area F.

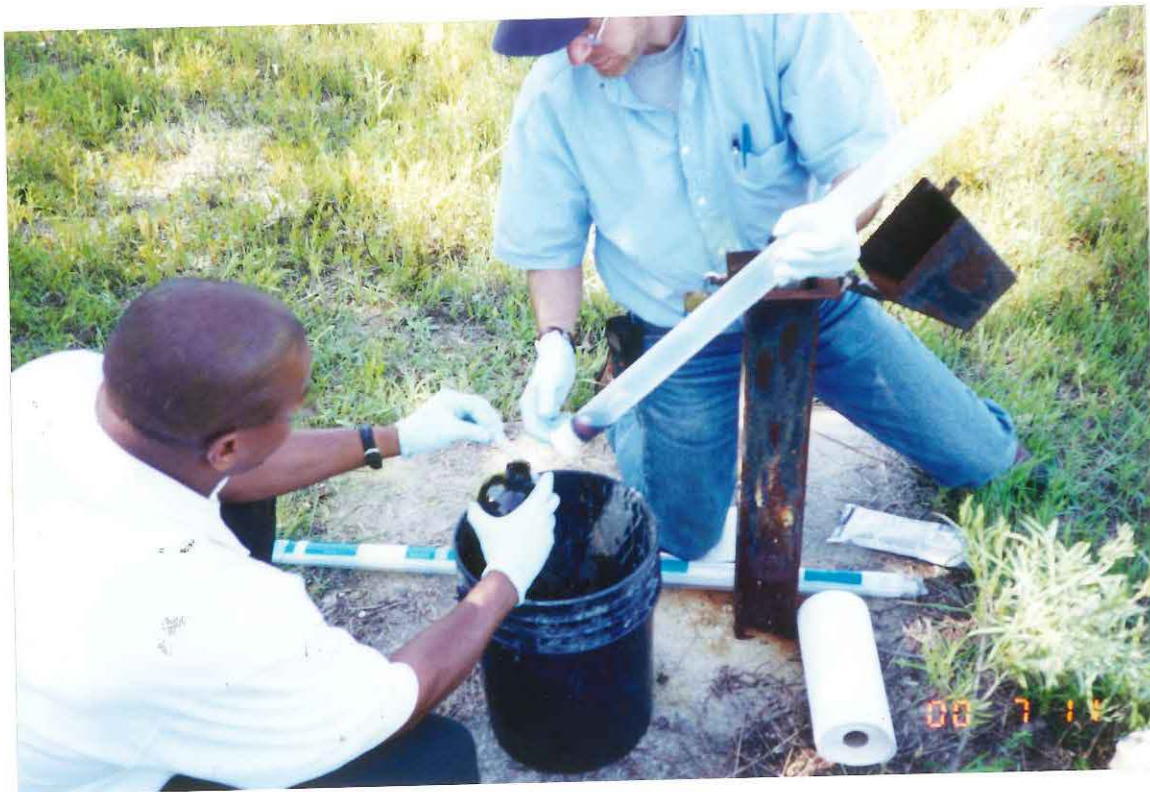
Photograph No.: R1-P17
Date: 07/11/00

Description: View of soil boring at TCE-17 location.

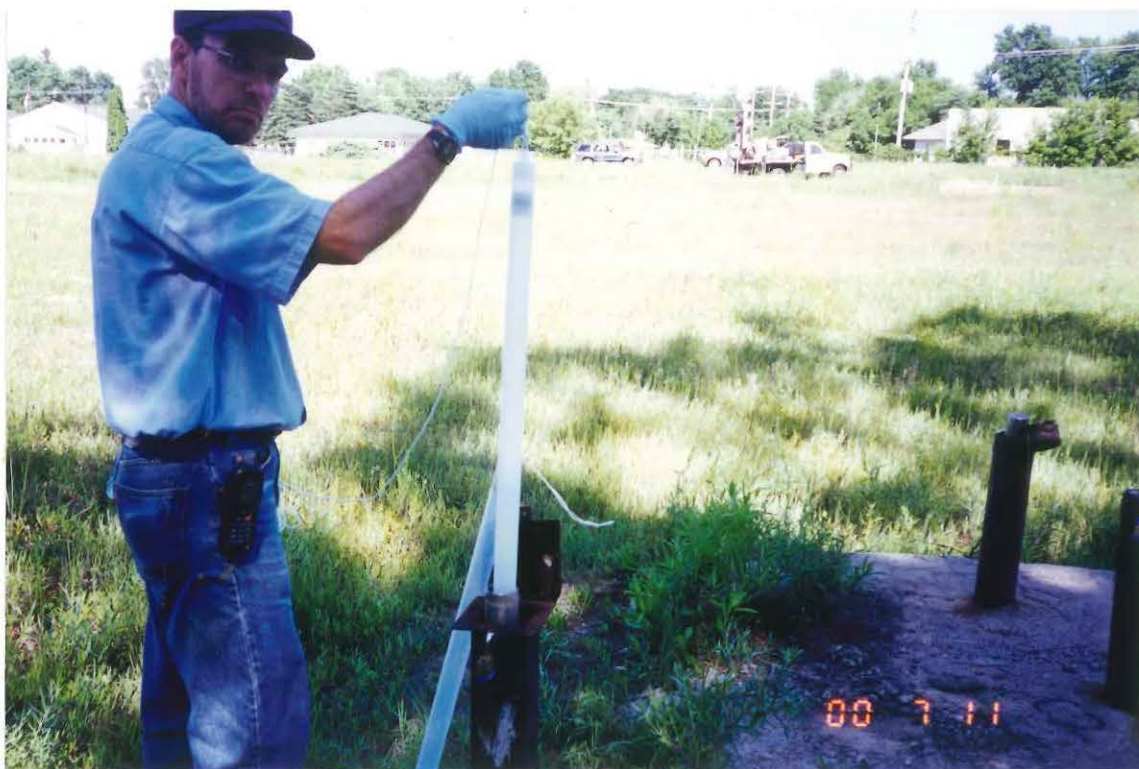
Photograph No.: R1-P18

Description: Continued collection of free product from MW-C3. Note MW-C1 and MW-C2 in background.

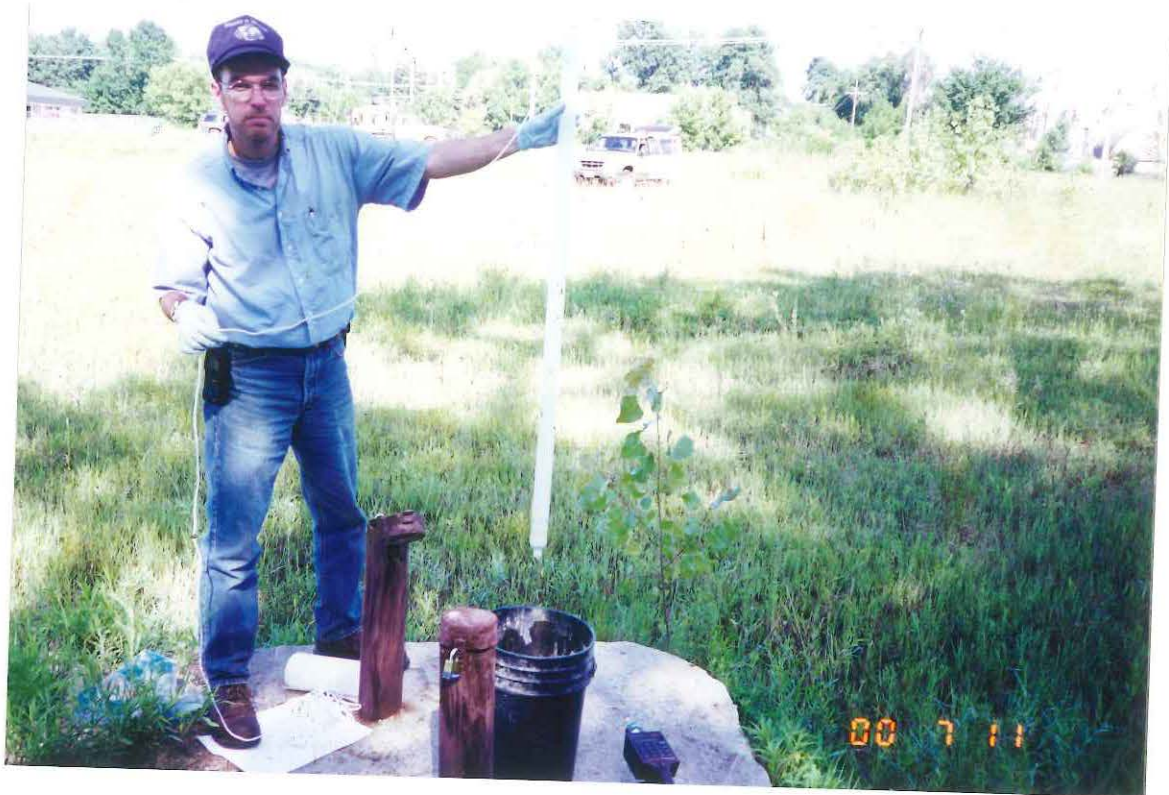
Photograph No.: R1-P20
Date: 07/11/00

Description: Continued collection of free product from MW-C3. Product was collected in glass sample jar and shipped to laboratory for characterization.

Mr. Connair noted that monitoring wells (MW) in the vicinity of SWMU C (Former Settling Pond) were found to contain free product during groundwater sampling conducted as part of the Phase III RFI. The free product was described as a light non-aqueous phase liquid (LNAPL). During the site tour, Mr. Connair removed a bailer from MW-C3. The bailer contained approximately 12 inches of LNAPL. Mr. Connair suggested that the contents may be kerosene. During the July 11, 2000 visit, a sample of the free product was collected as discussed in Section 2.3 below.

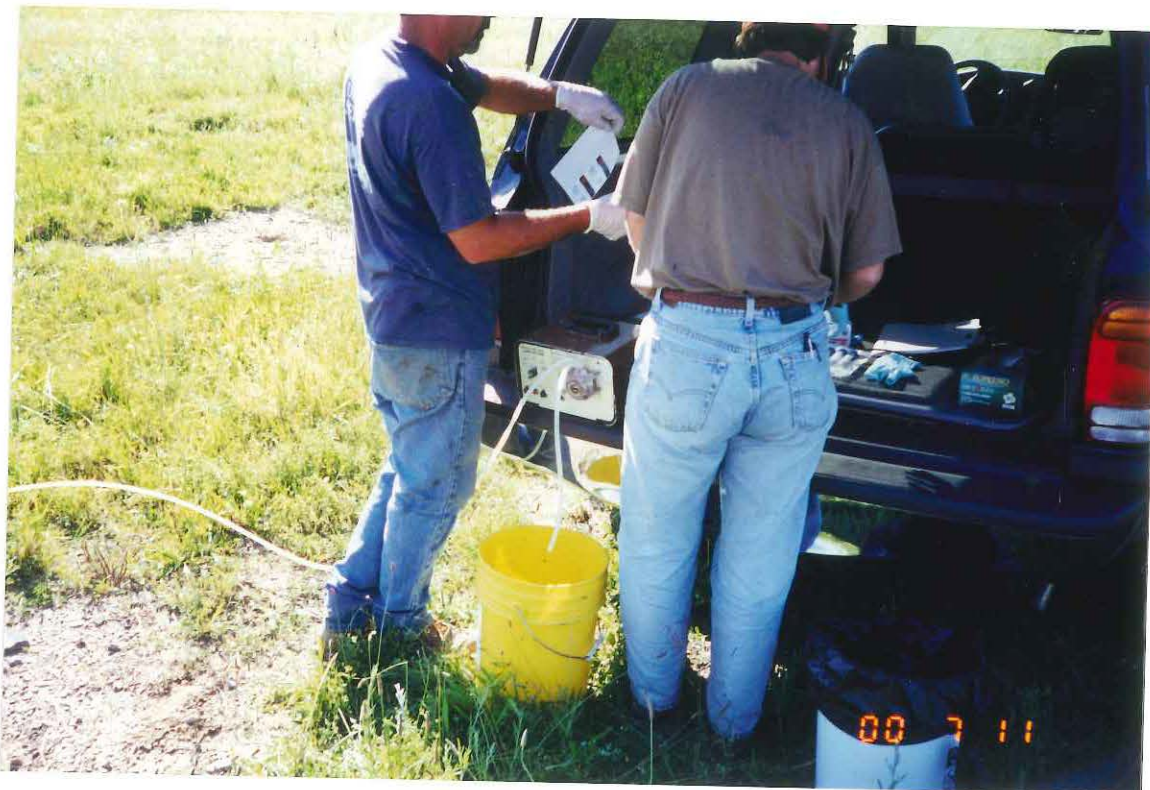
Photograph No.: R1-P21
Date: 07/11/00

Description: View of groundwater from MW-C1. No free product observed in well at time of visit. Mr. Connair noted that free product was visible in this well during the most recent groundwater sampling.

Mr. Connair noted that during groundwater sampling, free product was also encountered at the adjacent MW-C1. Using a new bailer, URS attempted to collect a sample. No free product was encountered at that time. Mr. Connair noted that it is possible that the free product was removed during well purging and has not regenerated.

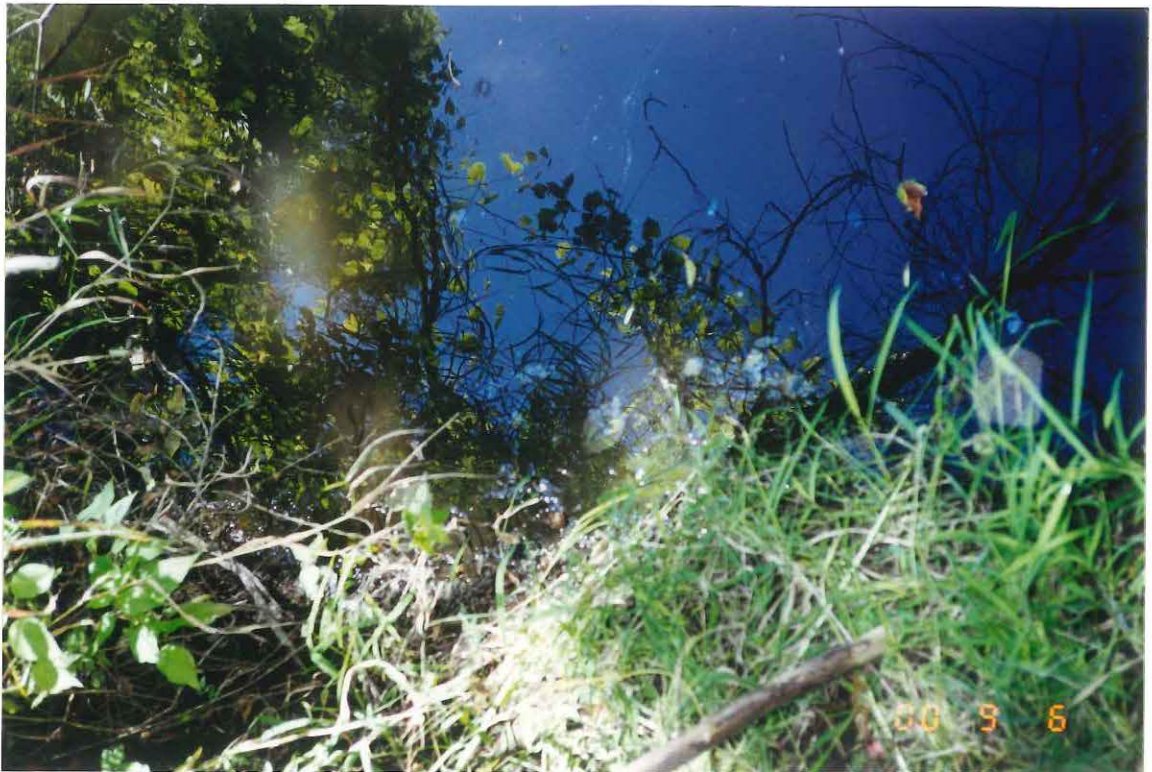
Photograph No.: R2-P2
Date: 09/06/00

Description: View of Mr. Dennis Connair conducting walking survey of the Red Cedar River. Mr. Connair is marking the location of a buried drum (not readily visible) for later sampling.

In addition to the sampling locations specified in the Work Plan, an additional sample was taken of river sediments. During the walking survey of the River on September 6, 2000, a 55-gallon steel drum was found partially buried in the River bottom. Based on visual observations, there appeared to be no environmental concerns with the drum. The drum had an opened end and was partially filled with sediment. This new sample was designated SE-RC-22A.

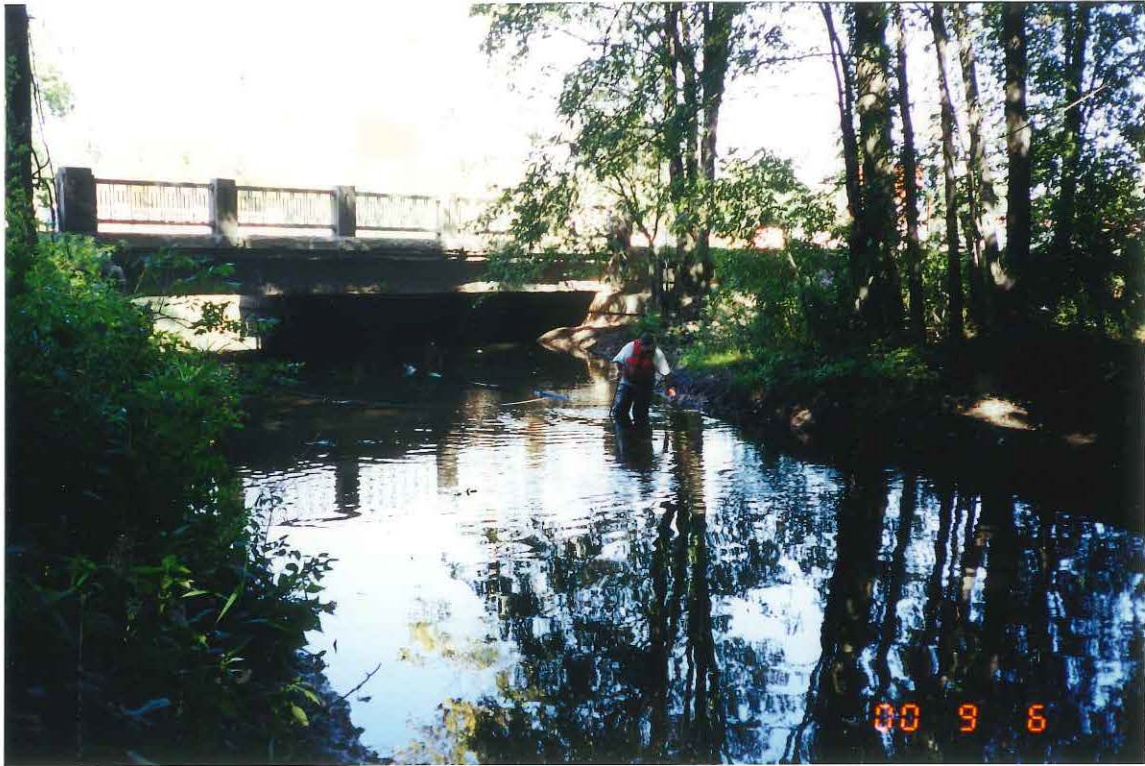
Photograph No.: R2-P3

Description: View of URS field personnel logging the depth of River sediment and water levels.

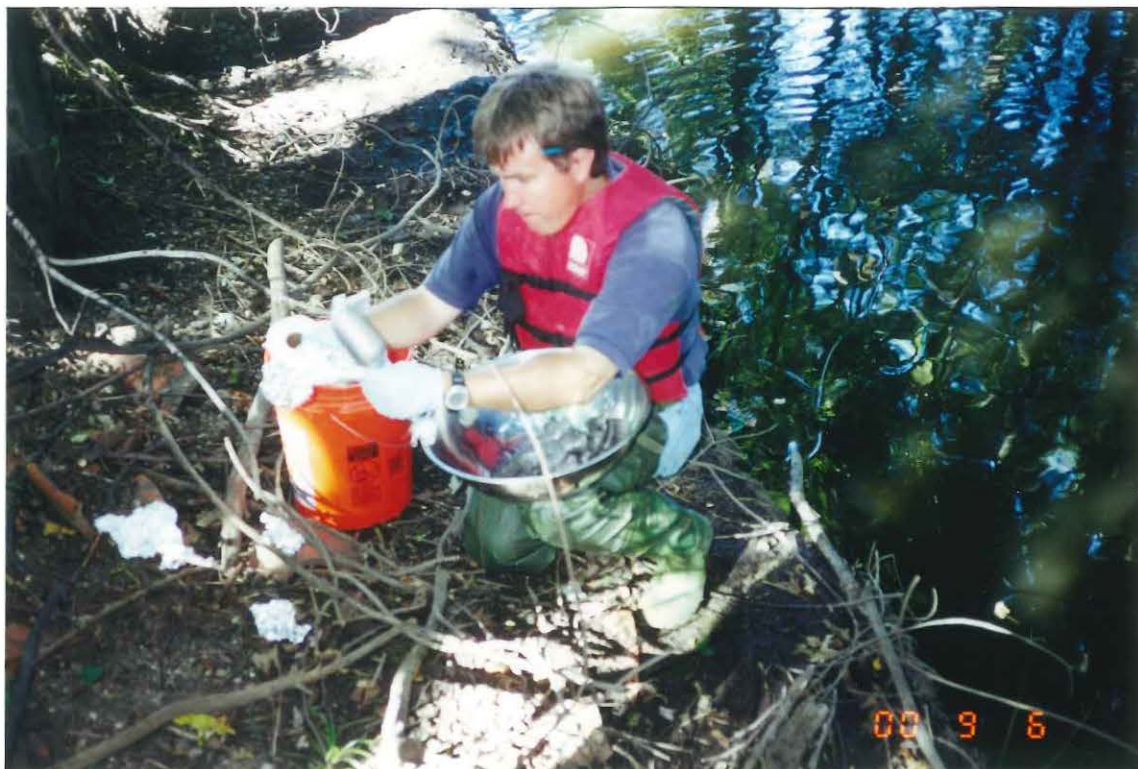
Photograph No.: R2-P4

Description: View of URS personnel collecting river sediment sample at location SE/RC-20.

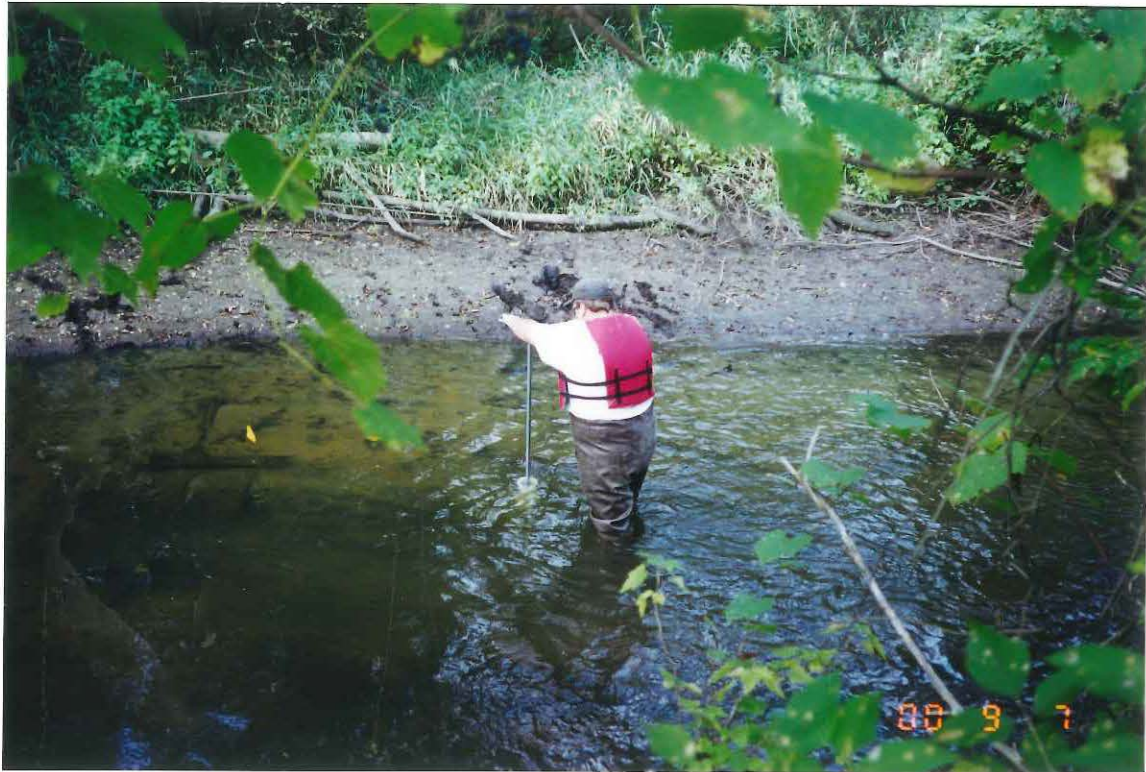
Photograph No.: R2-P6
Date: 09/07/00

Description: View of URS personnel collecting river bank sample SO/RC-22A in vicinity of SWMU J. A seep of an unknown oily substance is visible at this location.

River bank sampling was included as a revision to the Work Plan as documented in a March 30, 2000 letter from URS to U.S. EPA. The revision called for four bank samples co-located with River and South Ditch sediment sampling locations. During the walking survey of the River, Mr. Thomas and Mr. Connair identified an additional location for bank sampling. Along the river bank near SWMU J (waste water treatment plan), Mr. Connair and Mr. Thomas identified a potential seep of an oily hydrocarbon substance. A hydrocarbon odor and oily sheen was observed at this location at water level of the river bank. A bank sample was subsequently collected at this location using a stainless steel spoon. This sample was designated SO/RC-22A.

connection. A similar seep was also observed within the Red Cedar River adjacent to SWMUs E and J. Based on these factors, analytical results from the River soil and sediment samples should be rigorously compared with those from the adjacent SWMUs to determine if any connection can be made. In addition, careful consideration should be given to the characterization of the free product collected from SWMU C during the July 11 visit to determine if there is any similarity of the material to that apparently seeping into the Red Cedar River.

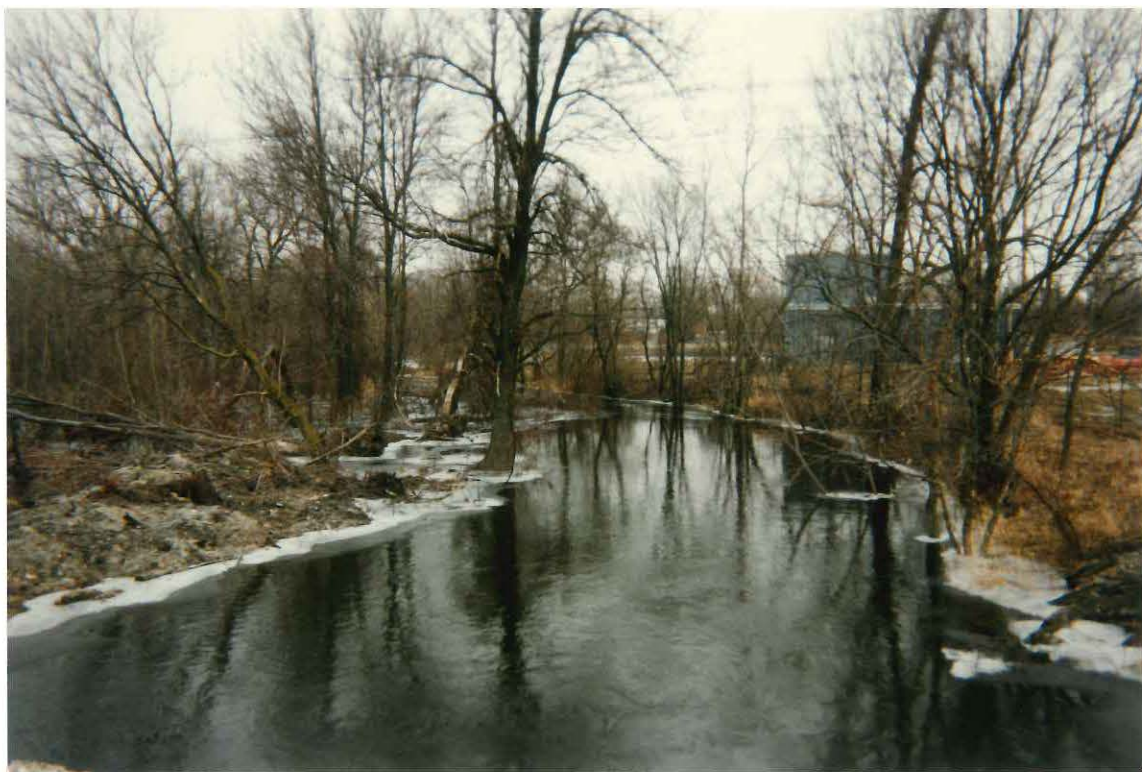
PHOTOGRAPH #77

View looking north from railroad bridge. Red Cedar River is flooded.

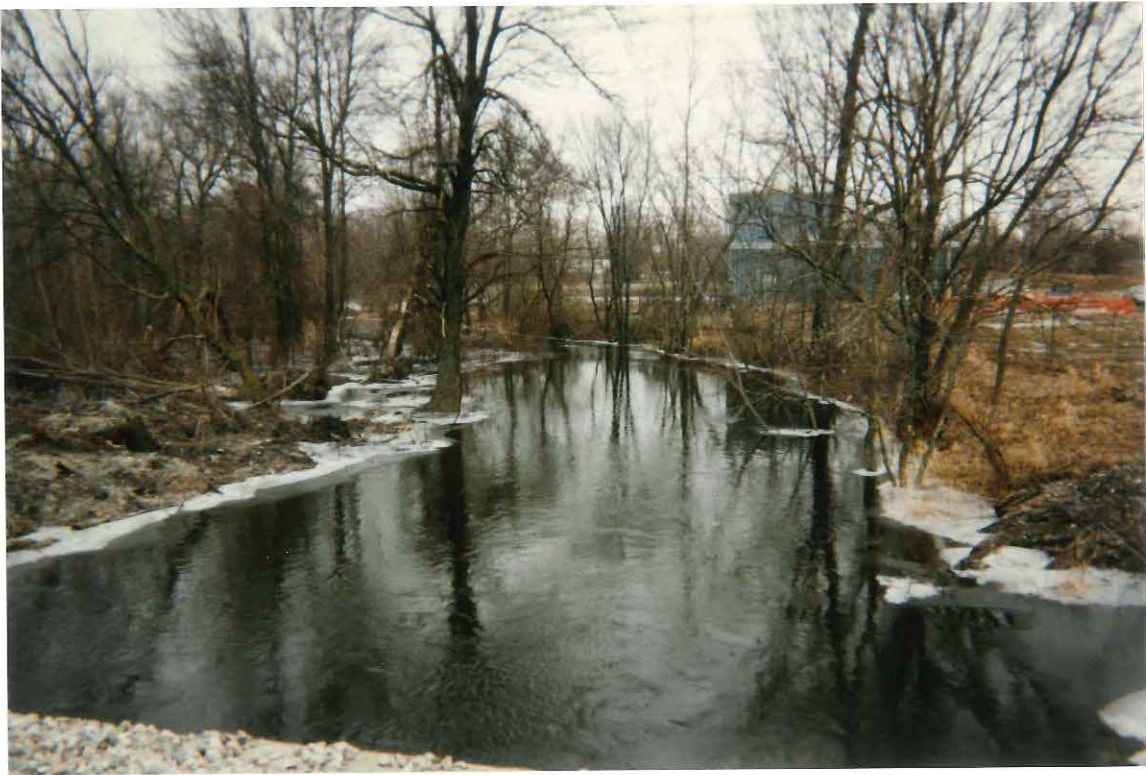
PHOTOGRAPH #78

View looking north from railroad bridge. Red Cedar
River is flooded.

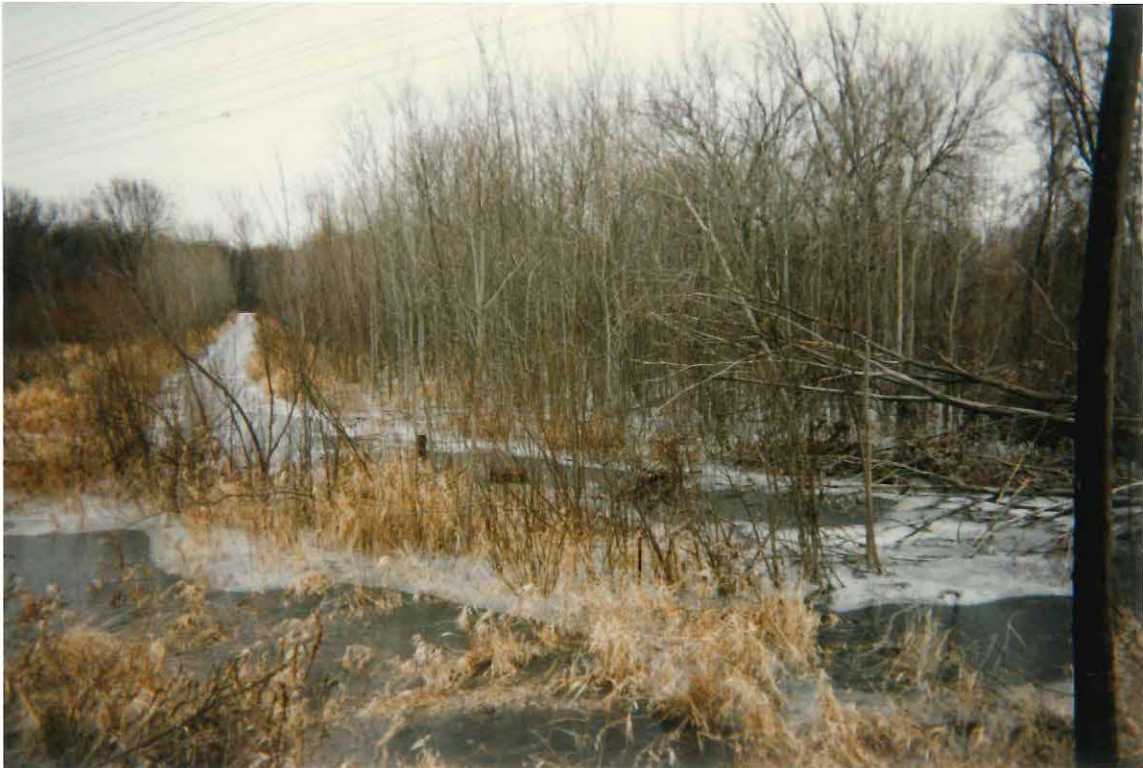
PHOTOGRAPH #79

View looking west from railroad bridge. Area where offsite wells located. Note: Well MW-0S1 in middle of photo.

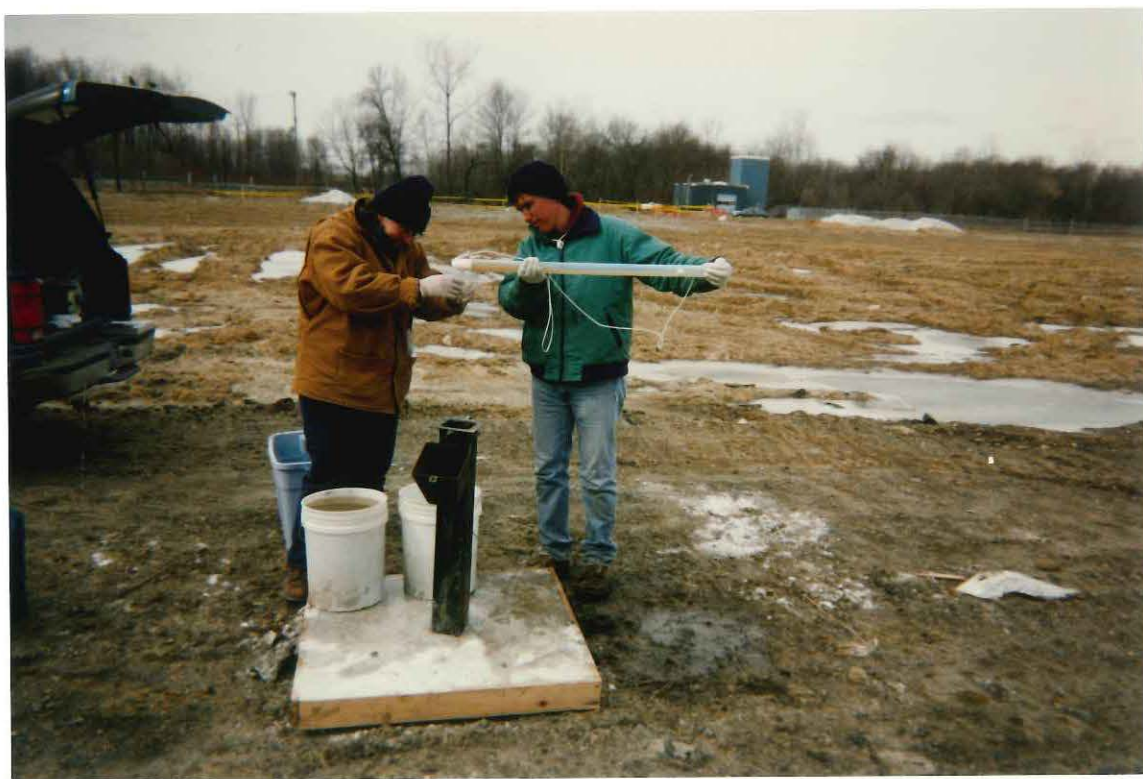
PHOTOGRAPH #80

Dames & Moore personnel sampling VOA's in well
MW-L1.

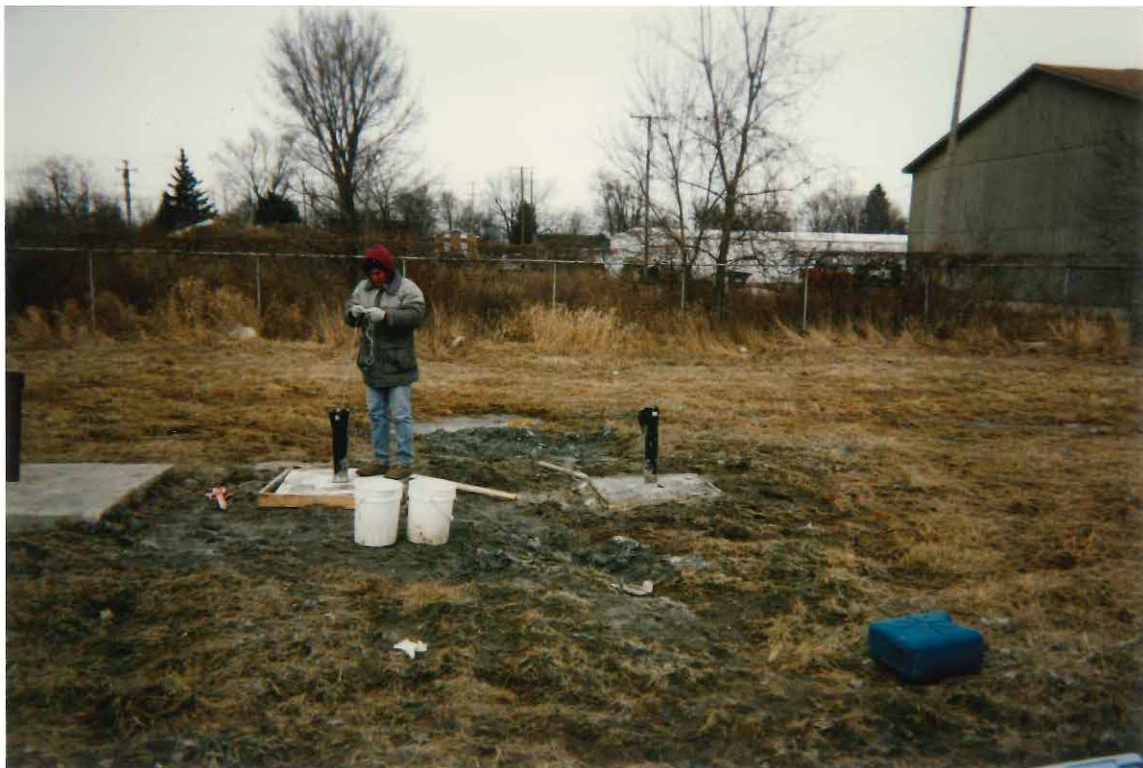
PHOTOGRAPH #81

Dave Eckhoff of Dames & Moore purging
background well MW-BCK3.

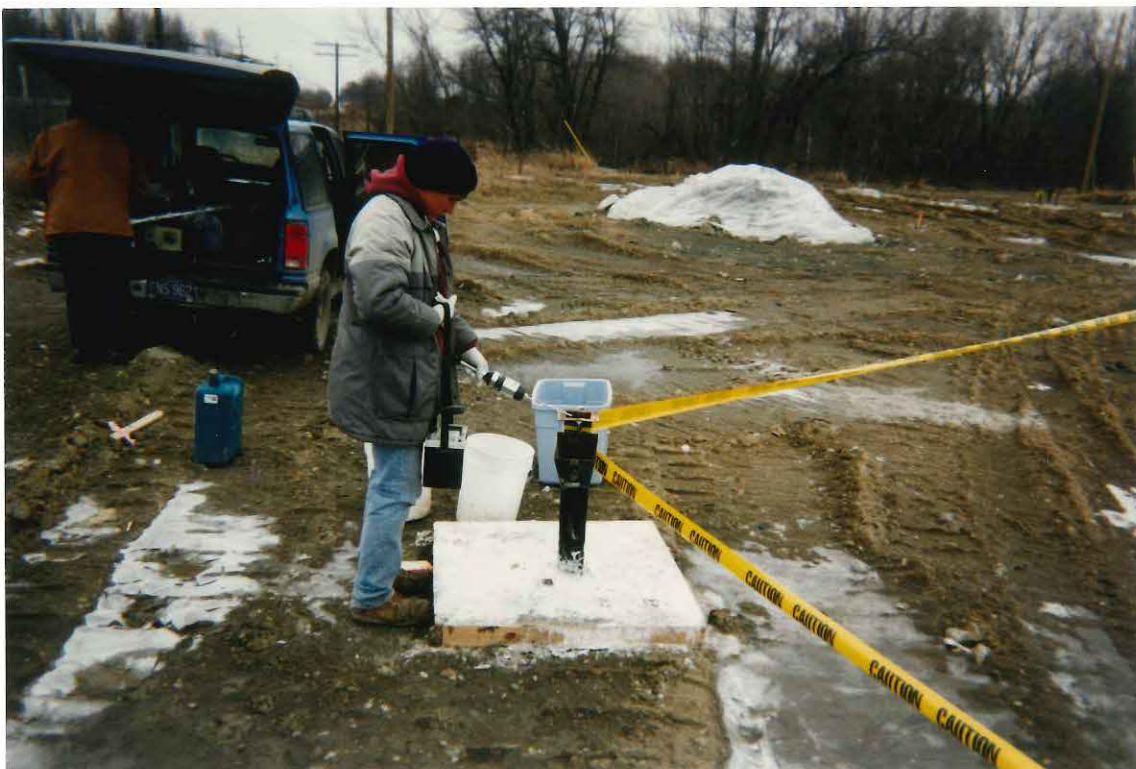
PHOTOGRAPH #82

Bill Eckhoff of D&M checking headspace on well
MW-K1 with an HNu.
